# Inspection Report

**Property Address:**  
333 Wild Raspberry Lane  
Lonsdale MN

## DREAM HOME INSPECTIONS

<b>Date:</b> 12/19/2007	<b>Time:</b>	<b>Report ID:</b> Sam 1
<b>Property:</b> 333 Wild Raspberry Lane Lonsdale MN	<b>Customer:</b> Sample Buyer	<b>Real Estate Professional:</b>

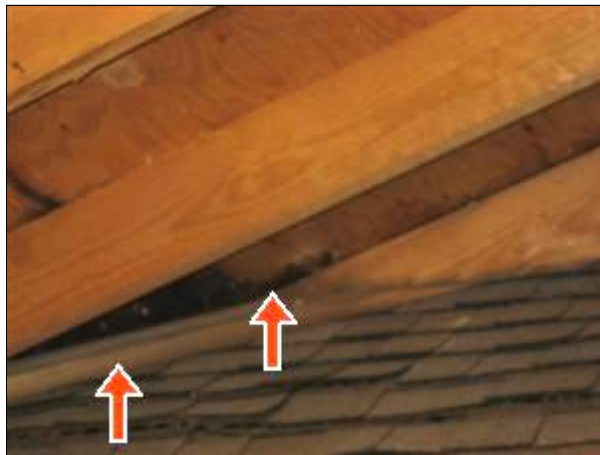
1.5 Picture 2

Leak signs in attic perhaps or likely from the *old roof* as this newer roof appears in tact. I am unable to determine if leak exists due to no recent rain.

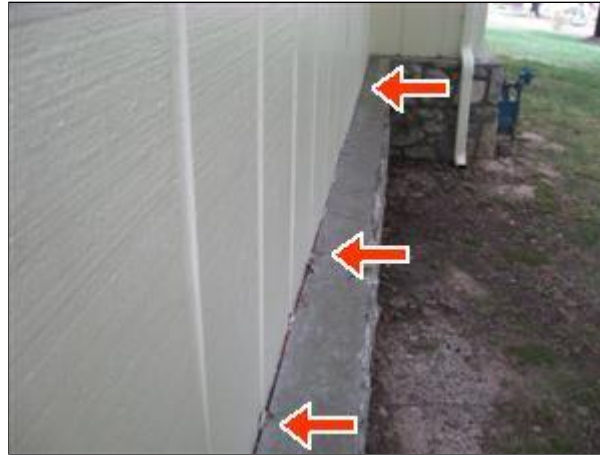
2.0 Picture 1

Periodical maintenance caulking needed and recommended to keep water from weeping under siding at concrete shelf. FYI

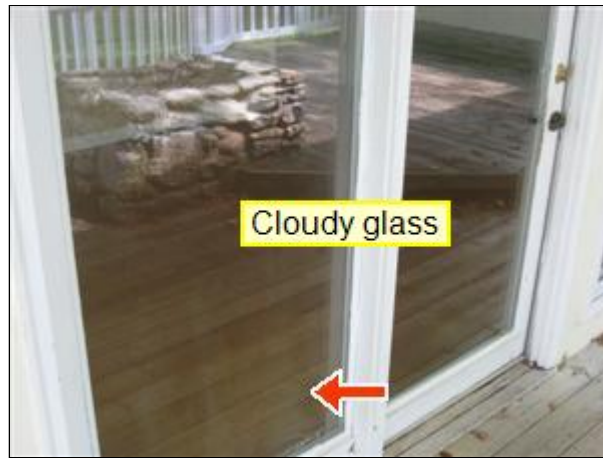
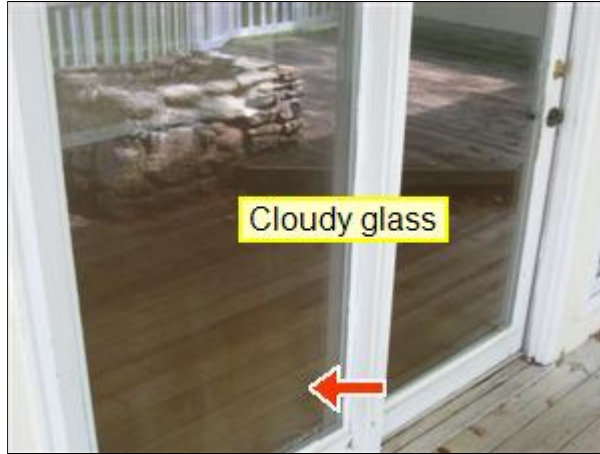
2.1 Picture 1

Patio doors at rear of home are cloudy or seal is broken. Glass panes that have lost their seal (cloudy) can usually be replaced without replacing the entire unit. A qualified contractor should inspect and repair as needed.

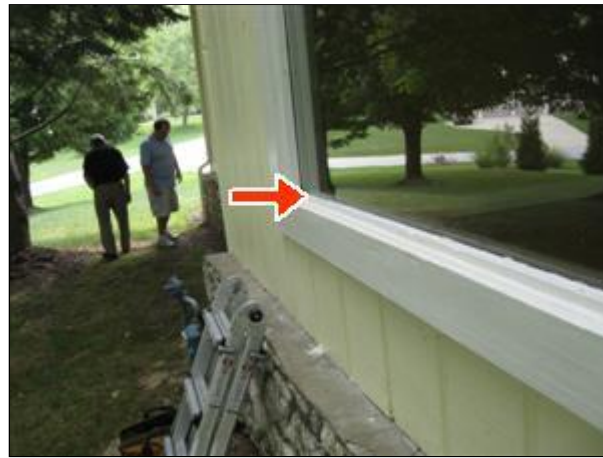
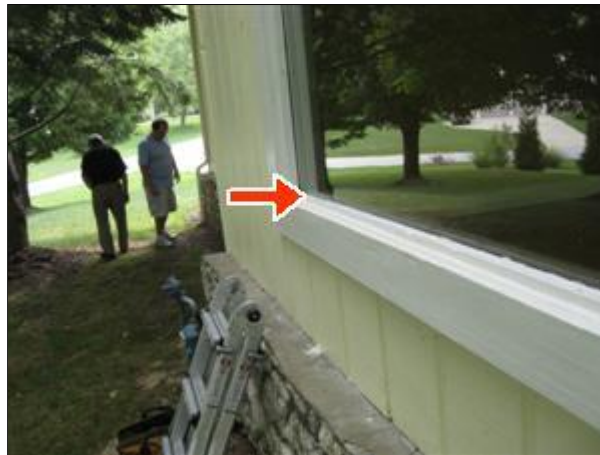
2.2 Picture 1

The trim stop for fixed pane is weathered and indicates that water may be getting below trim. I recommend a paintable sealant be applied and paint trim.

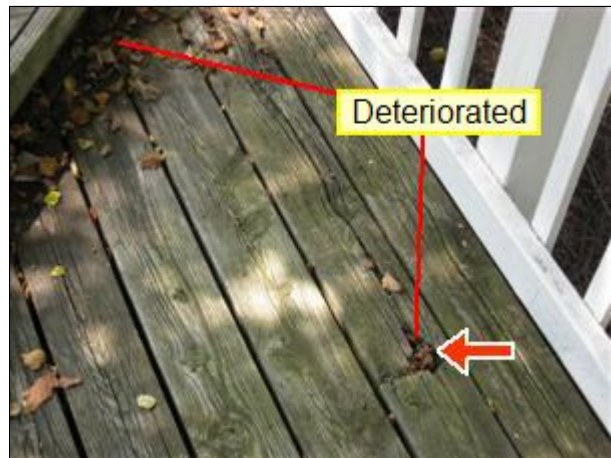
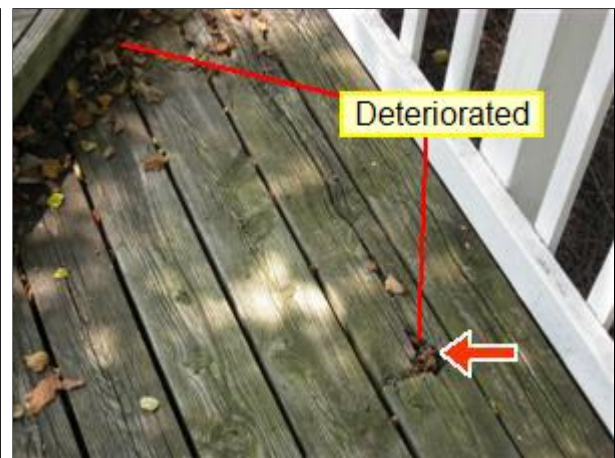
2.3 Picture 3

(2) The 2x6 decking on the deck at the rear of home has several boards that are deteriorated. A general replacement is likely. A qualified contractor should determine whether a repair or replacement is needed.

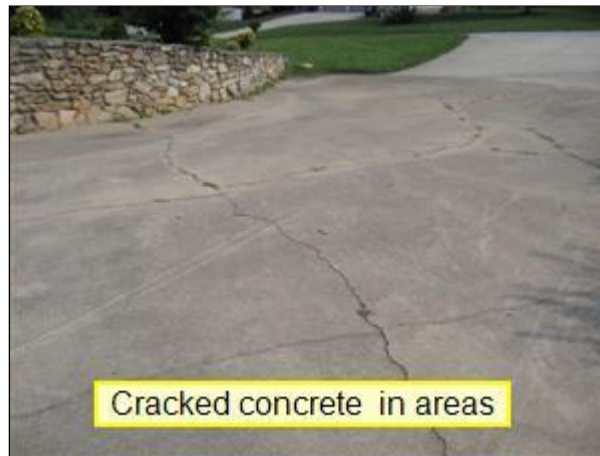
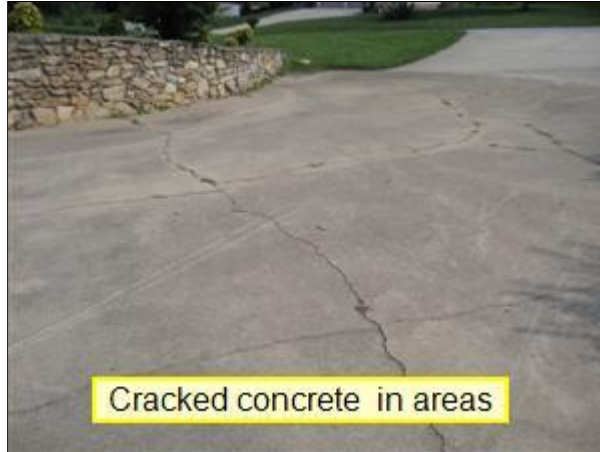
2.4 Picture 1

The concrete drive at the front of home is is pitted in areas and has settlement cracks. Further deterioration can occur if not repaired. A qualified contractor should inspect and repair as needed.

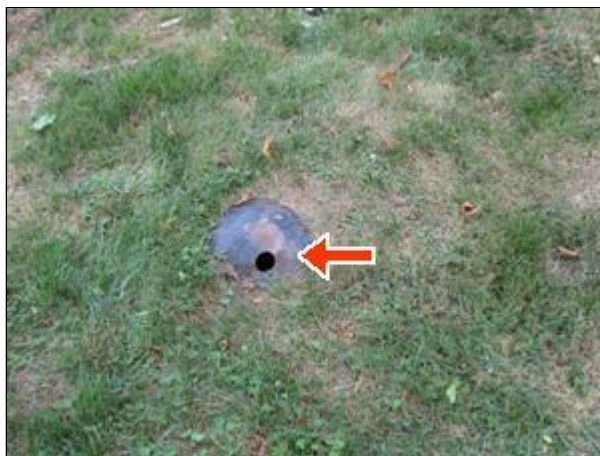
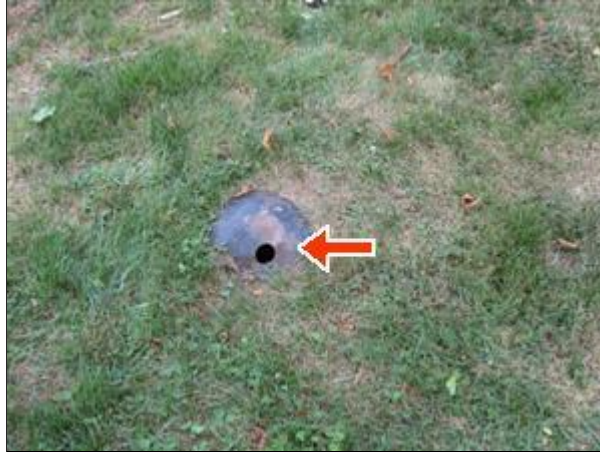
2.6 Picture 1

(1) Old propane tank in ground and is discontinued. I did not determine if gas remains in discontinued tank? I recommend further investigation by a qualified person.

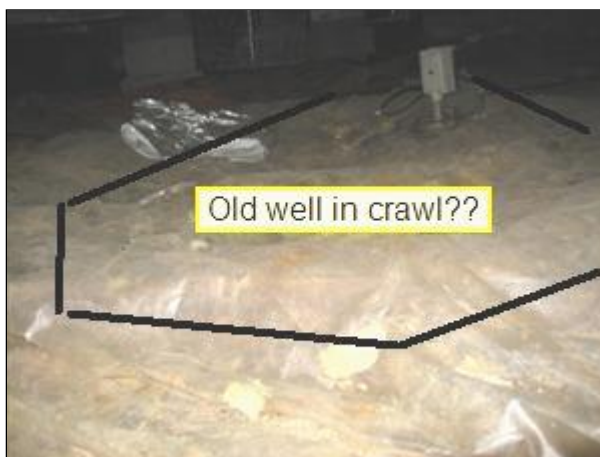
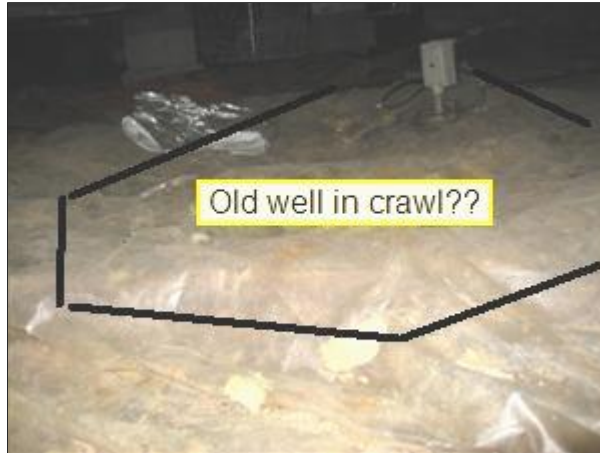
2.6 Picture 2 in crawlspace under new addition

(2) There is an odd configuration in ground under addition in crawlspace. This may be an old well? I am unable to determine. I recommend a qualified well drilling company or plumber investigate further to determine if any further action is needed to correct.

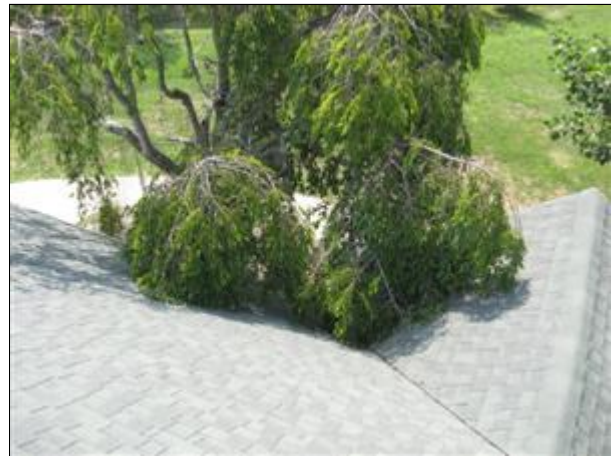
3.0 Picture 2

(1) The tree limbs that are in contact with roof or hanging near roof should be trimmed.

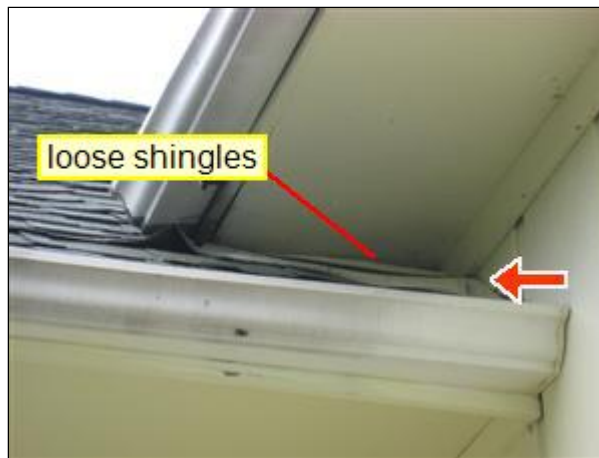
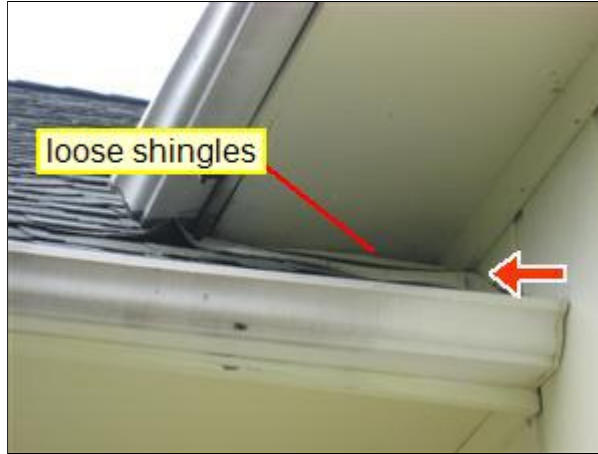
3.0 Picture 3

(2) Shingles loose under eave at front of home, needs adhesive.

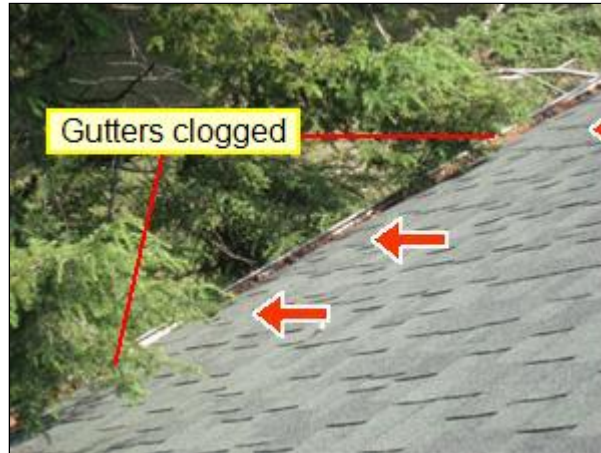
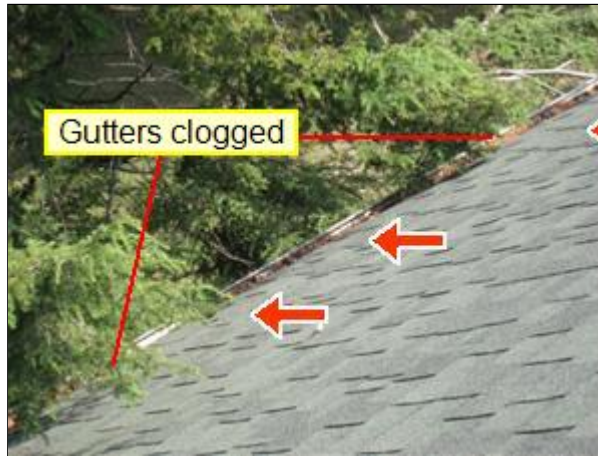
3.3 Picture 1

The gutter needs cleaning of debris at the virtually all areas where gutters are installed. Gutters that drain poorly or clogged can lead to many costly problems such as deterioration of fascia, soffit or roof edge. It can also cause gutters to pull loose and lead to possible water intrusion. A qualified person should repair or replace as needed.

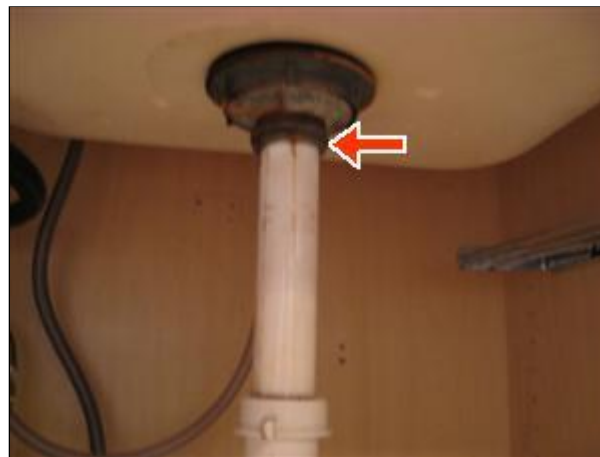
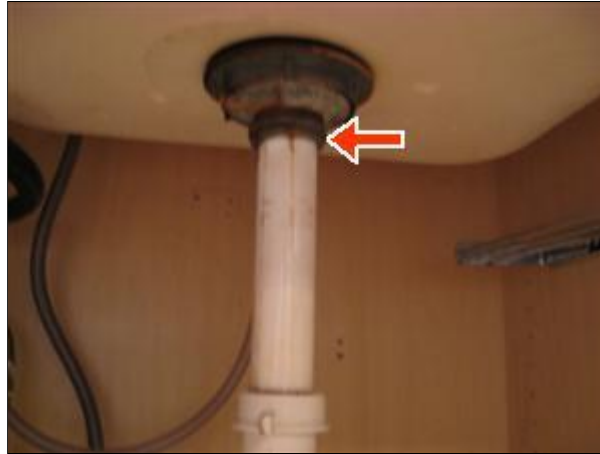
4.0 Picture 1 Right sink basin

(1) The basket strainer had leaked and corrected itself for the time being at the Kitchen sink. Repairs are needed. A qualified person should repair as necessary.

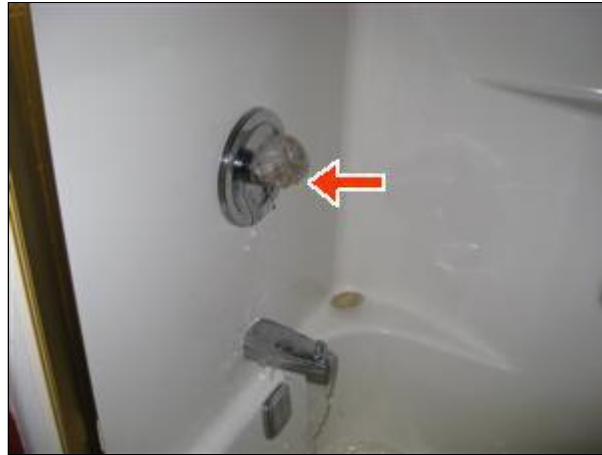
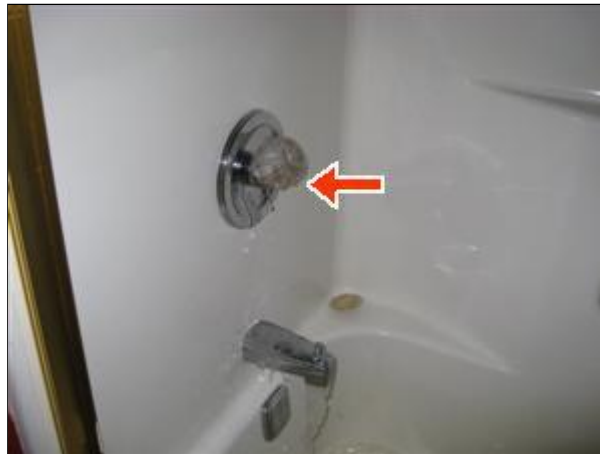
4.1 Picture 1 hall bath

(1) The control knob leaks at the hall bath. Repairs are needed. A qualified licensed plumber should repair or correct as needed.

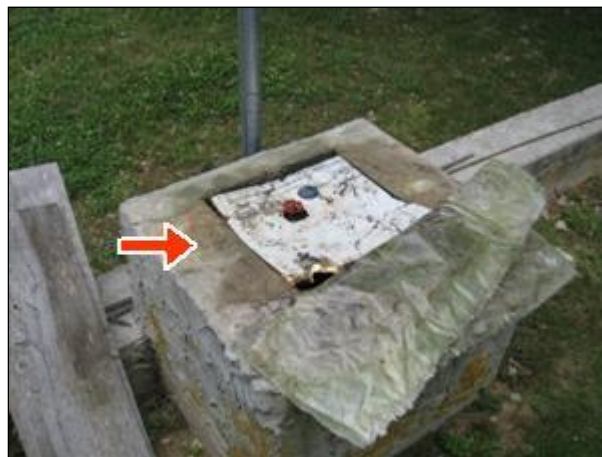
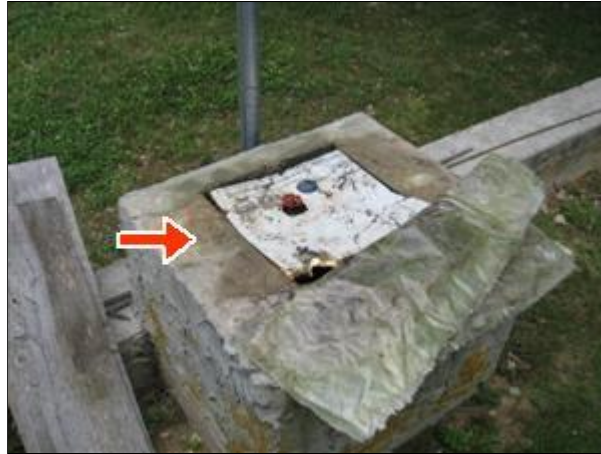
4.1 Picture 3 Well head

(3) I recommend the well head lid be insulated better before winter. FYI

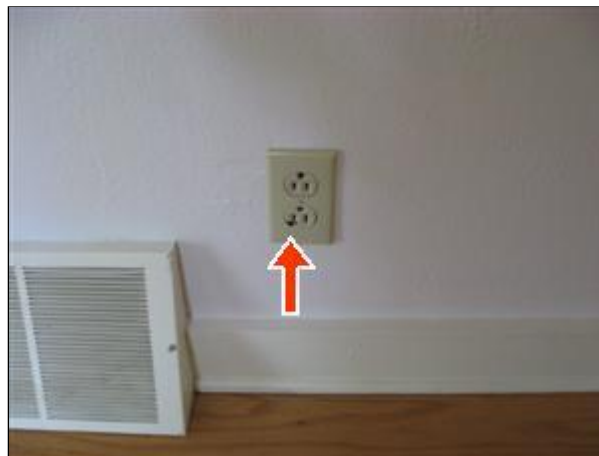
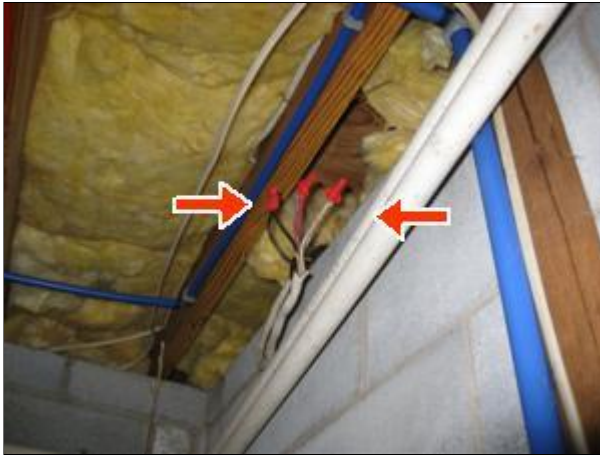
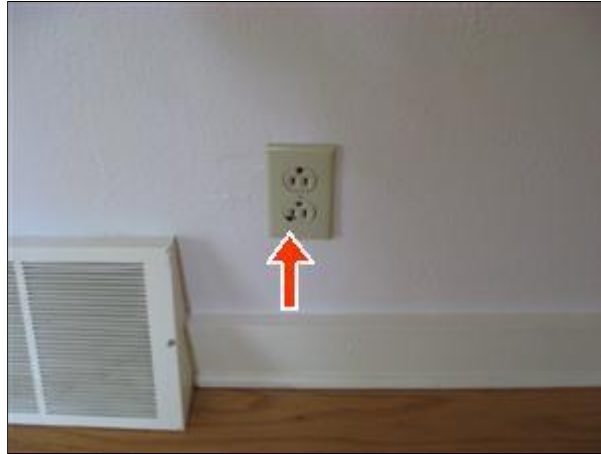
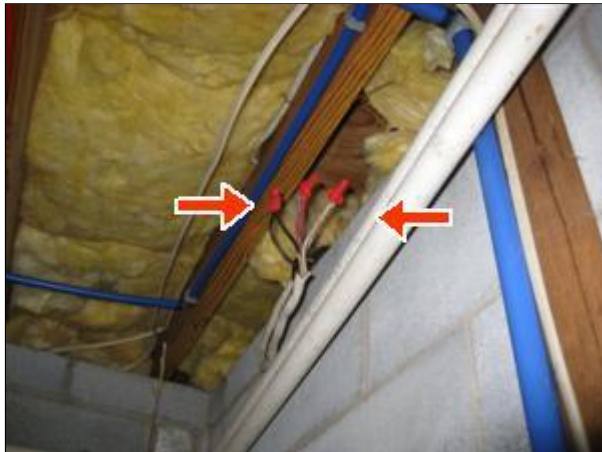
5.3 Picture 1

(1) The wall switch is broken (unsafe) at the upstairs closet for air handler. At least two outlets are broken at LR and entry way. Electrical issues are considered a hazard until repaired. A qualified licensed electrician should perform repairs that involve wiring.

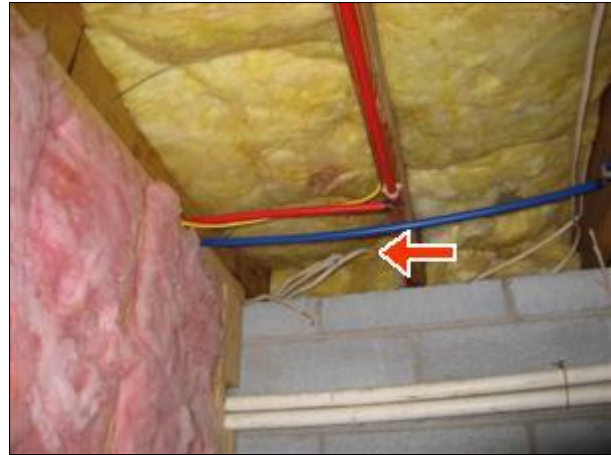
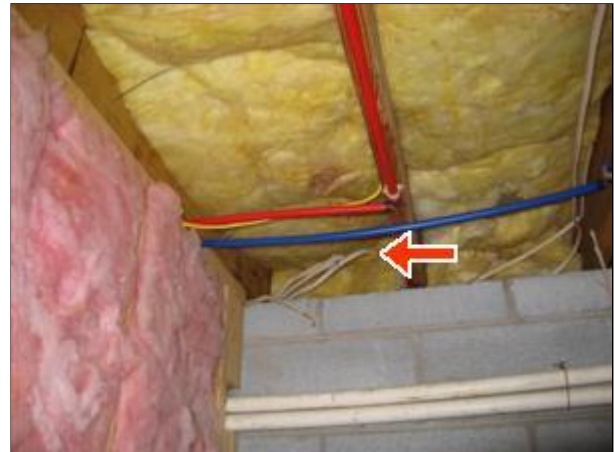
5.3 Picture 3

(2) Several loose wire ends needs placing inside a box with a cover-plate in the basement at the pressure tank of well. I recommend repair as needed.

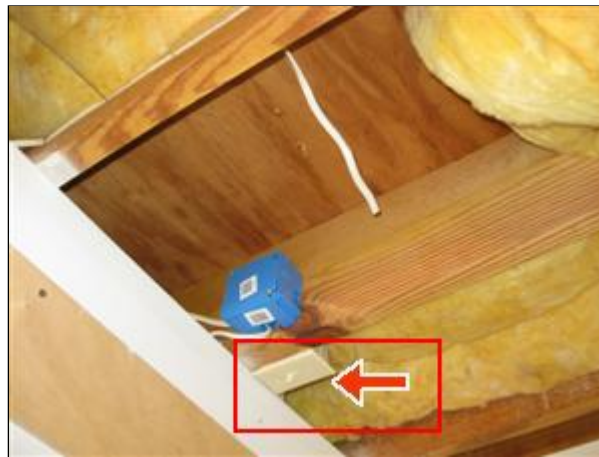
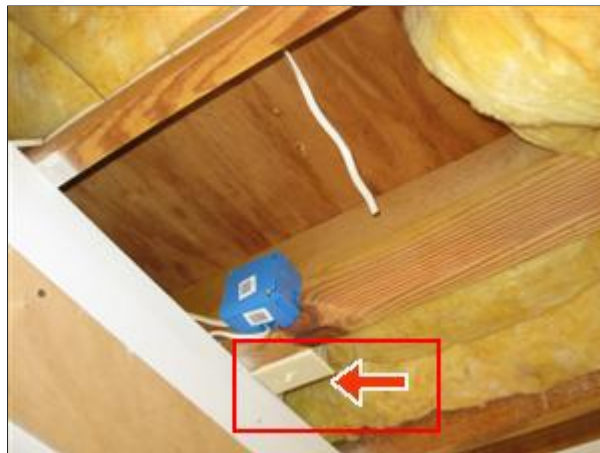
5.3 Picture 4

(3) Wall switch on ceiling in Garage, purpose unknown

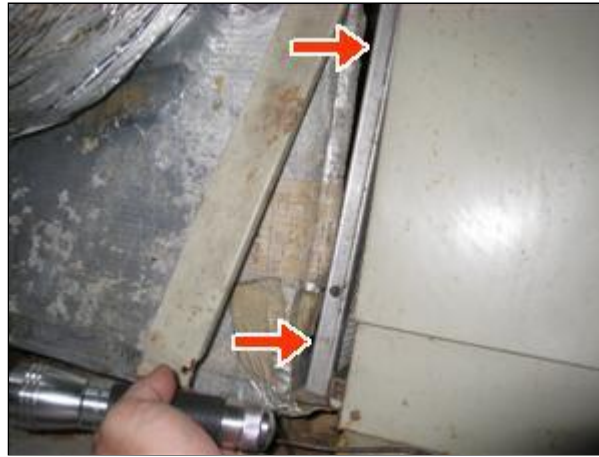
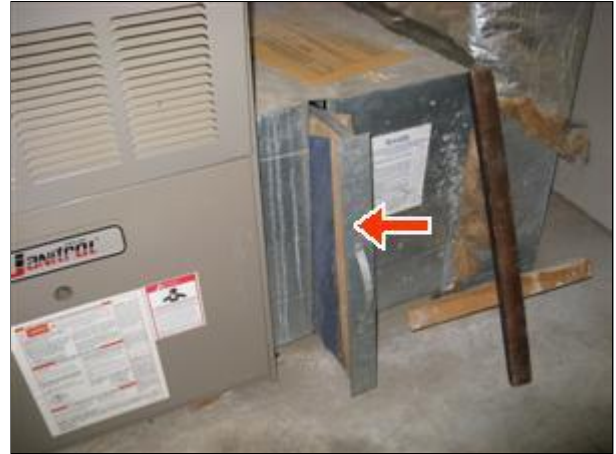
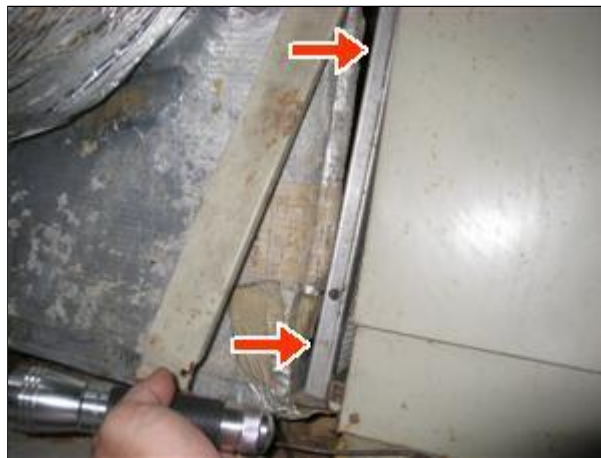
6.3 Picture 3

(1) The washable filter is collapsed and needs replacing at upstairs. The filter needs replacing with a rigid frame to prevent filter from falling out of alignment. ( Picture 1 ) The filter in basement ( Picture 2 ) needs replacement and in crawlspace which is difficult to access due to the crawlspace ( Picture 3 ). A qualified person should repair or replace as needed

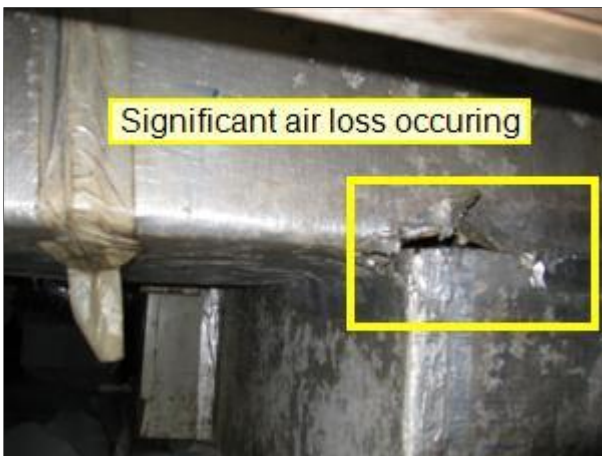
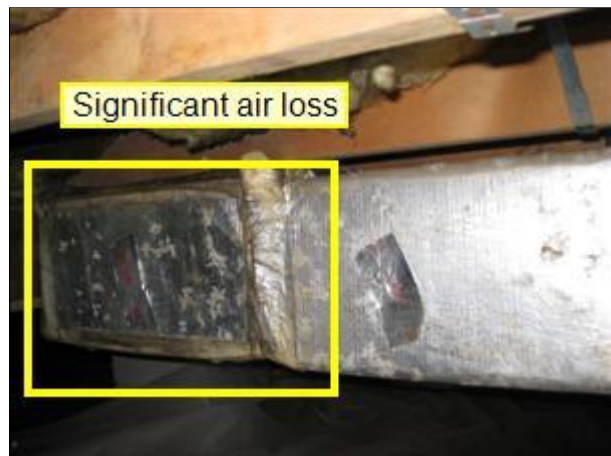
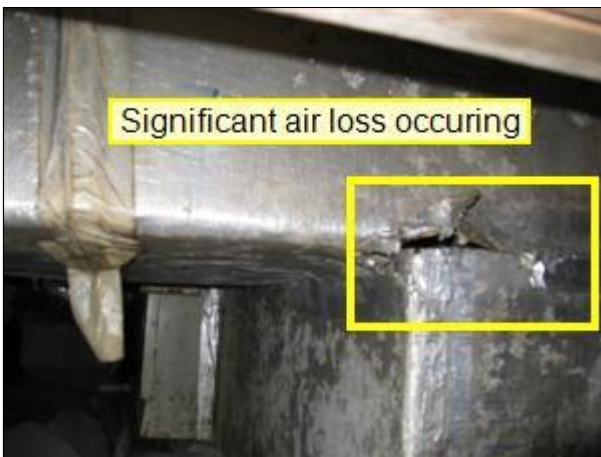
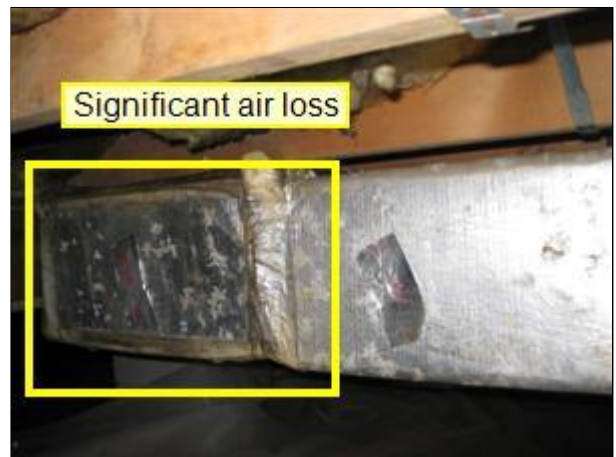
6.3 Picture 5

(2) The supply duct pipe or main plenum is failing in the crawlspace. Energy loss is occurring in crawlspace and immediate correction is needed. A licensed HVAC contractor should service or repair unit.

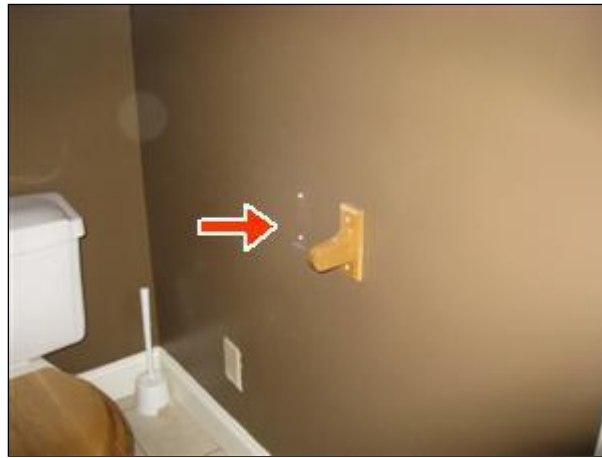
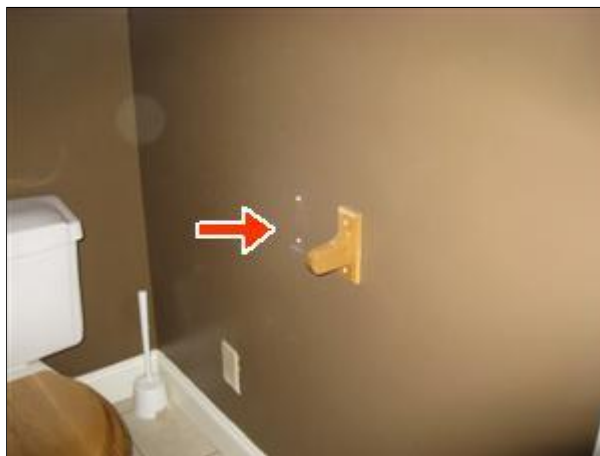
8.1 Picture 1

The tissue holder on the wall is damaged at the master bath. I recommend repair as necessary.

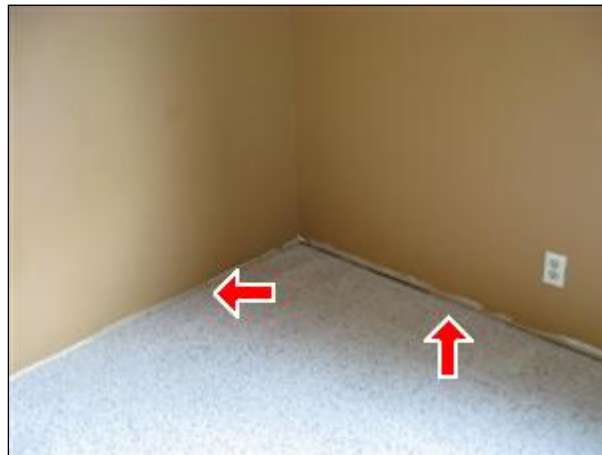
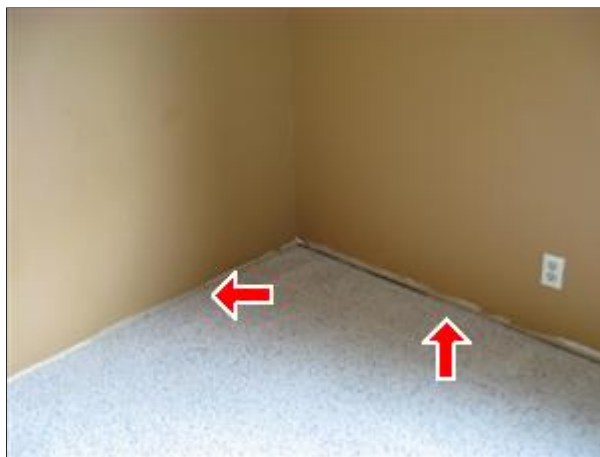
8.2 Picture 1

(1) The Baseboard is missing at the upstairs (right of hall bath). Repairs are needed. A qualified contractor should inspect and repair as needed.

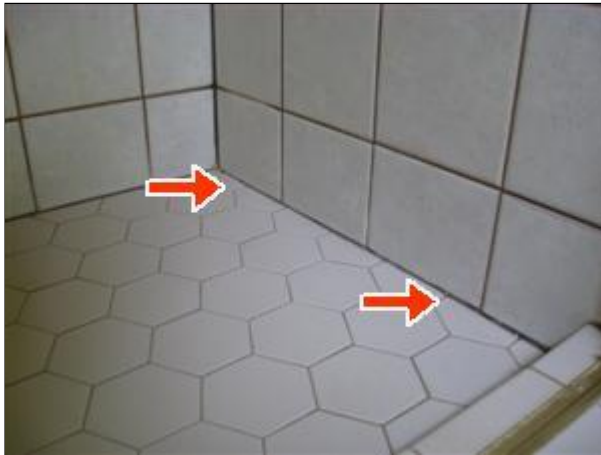
8.2 Picture 3

(2) Tile at shower pan and wall surround are loose and missing mortar or grout and sealer at the upstairs bath. Repairs are needed to prevent water damage to shower/bath. A qualified person should repair or replace as needed.

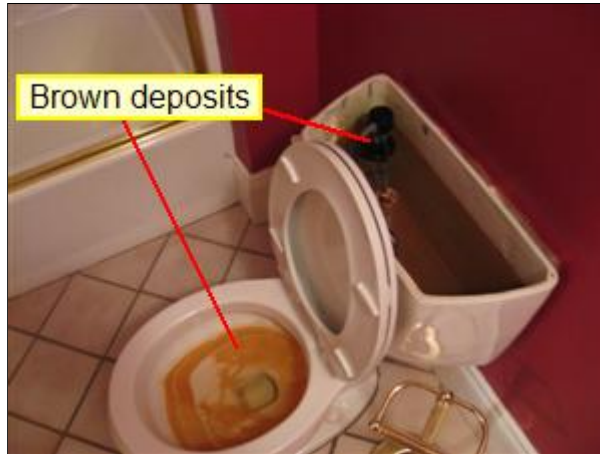
4.1 Picture 2

(2) Brown deposits are on the plumbing fixtures which indicates a filter may be needed. Filter in place and appears dirty but I am unable to determine if you need a different or additional filter. I did not test water for bacteria or other. I recommend contacting a water filtration company.
